To: File
From: Andy Hummel, P.E.
CC: Ron Korman, Dan Hamlin
Date: 5/31/2013
Re: Raincheck Stormwater Training, attendees list

<p>City of Sparks 431 Prater Way Sparks, NV 89431</p>	<p>Maintenance Facility Stormwater Management Plan</p> <p>Main Yard on S. 21st Street</p>

find the specific audit findings that were identified as “program deficiencies or potential permit violations” in bold followed by SWPCC response noted in italics.

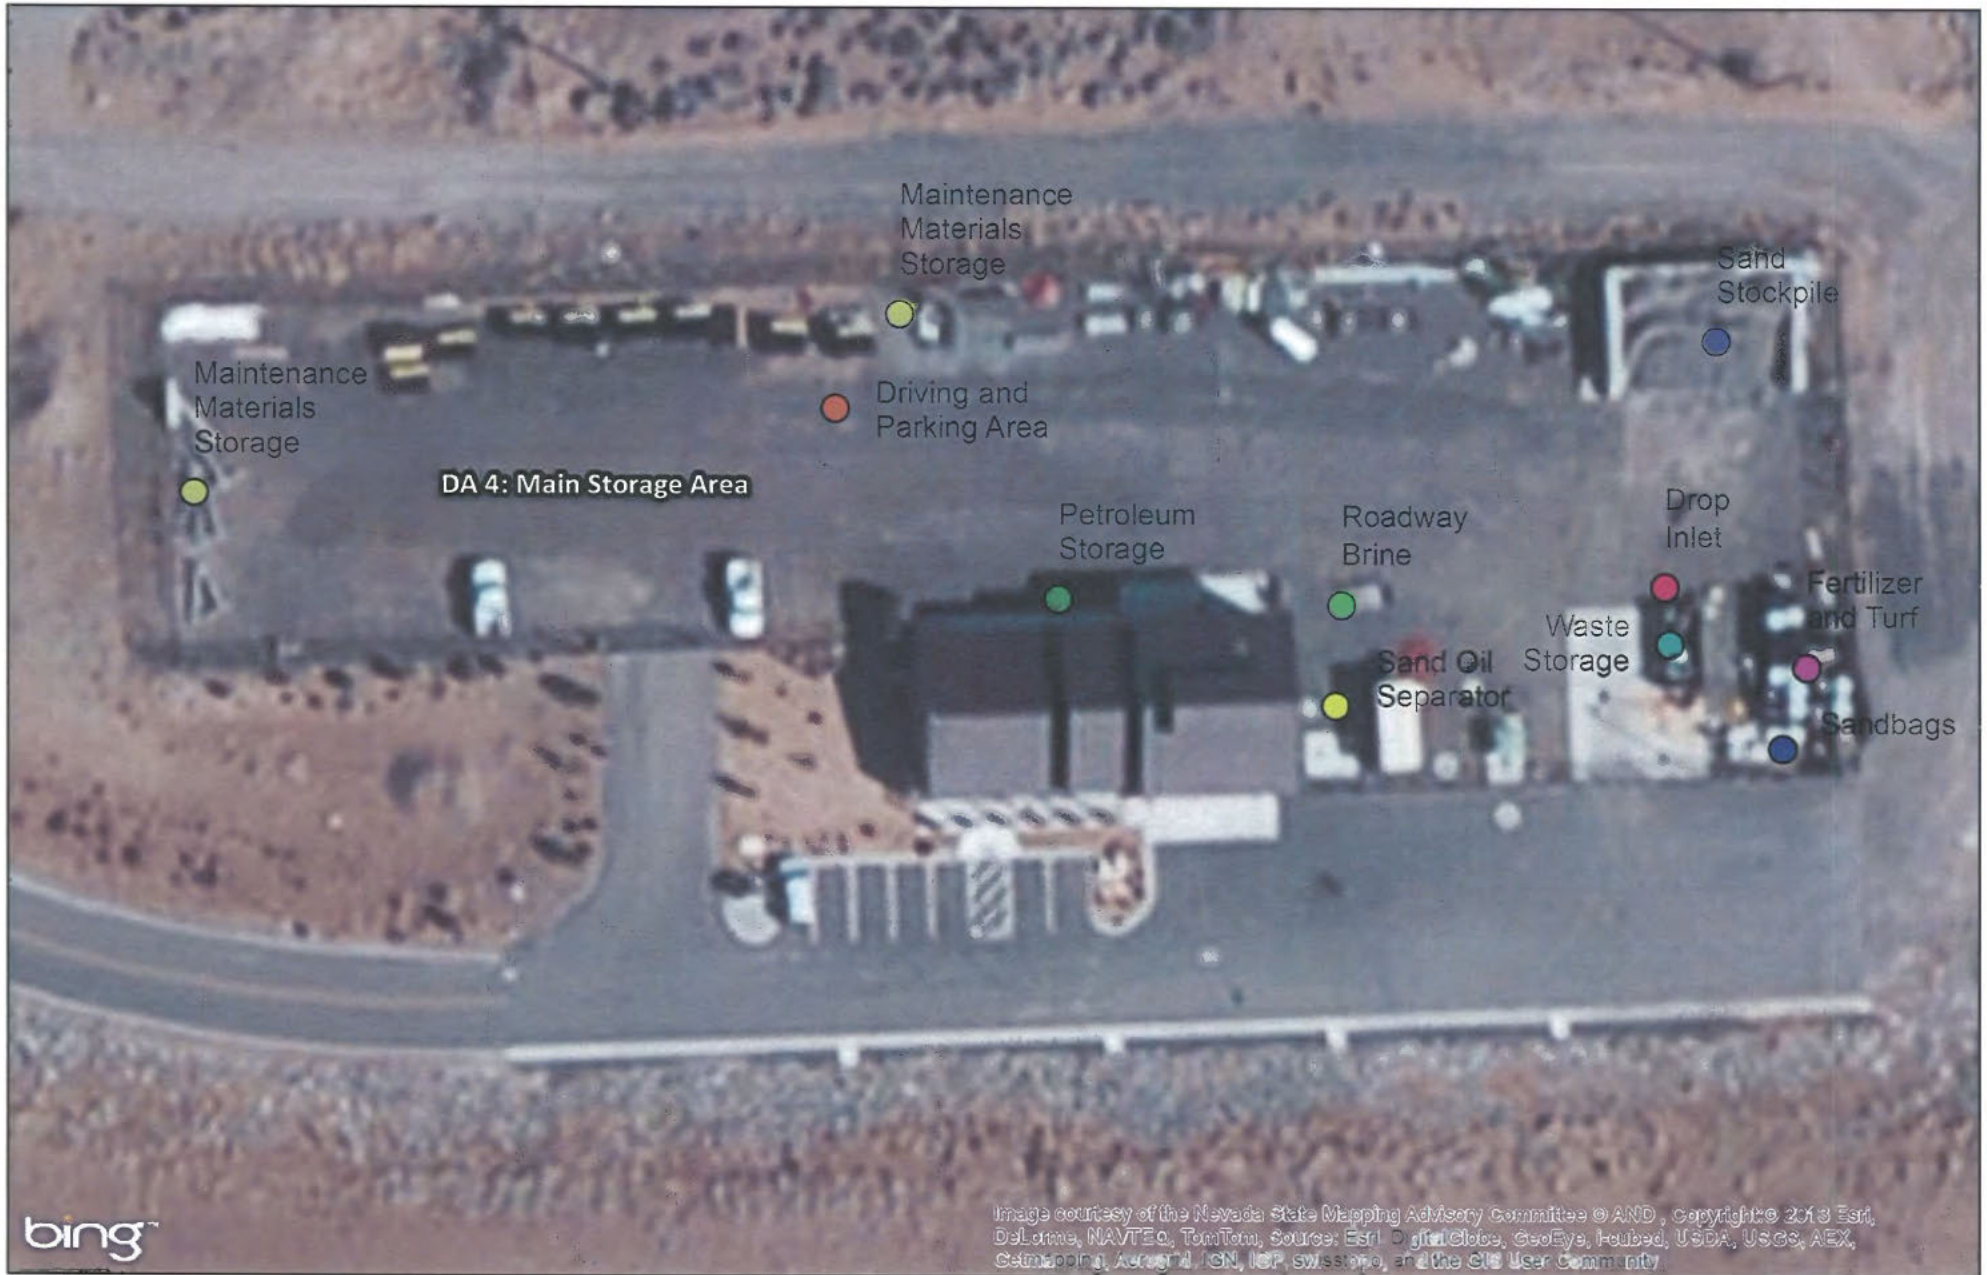
<p>City of Sparks 431 Prater Way Sparks, NV 89431</p>	<p>Maintenance Facility Stormwater Management Plan</p> <h2>Horsemen's Yard</h2>			  <p>NICHOLS CONSULTING ENGINEERS, Chtd. Engineering & Environmental Services P.O. Box 1760 Zephyr Cove, NV 89448 775 588 2505 (ph) 775 588 2607 (fax)</p>
	<p>0 90 180 Feet</p>  	<p>Data Sources: GeoJot Site Visit</p>	<p>Date: JUNE 2013 Drawn by: KMS/NCE</p>	<p>Figure: 3</p>

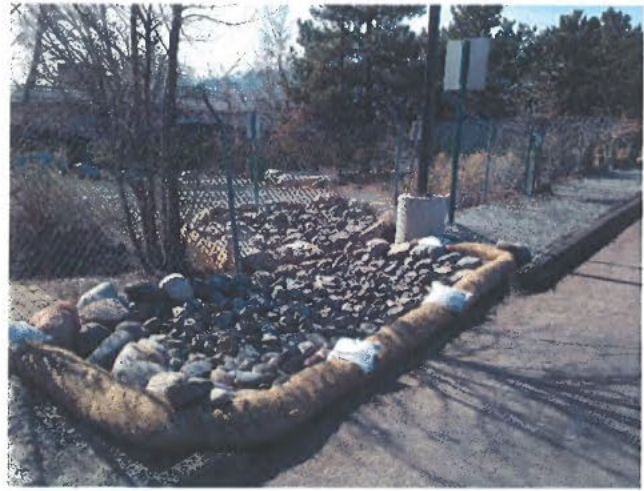
Photo 2

The Curb has been installed directing the flow to a low point where a basin has been constructed, lined with rip rap, attenuating flows and allowing sediments to settle. Fiber rolls will be maintained at the entry and exit points to further capture fines.

This has been remedied (See Reno photos 1, 2 & 3). A permanent BMP has been installed. The lower part of the parking lot has been paved and an asphalt curb added to prohibit sheet flows from leaving the site. A curb cut has been added at the low point to allow the flow to enter basin lined with rip rap. A fiber roll has been placed at the entry point to prevent fines from entering the basin. The rock placement is permanent; the fiber rolls will be monitored and replaced when warranted.

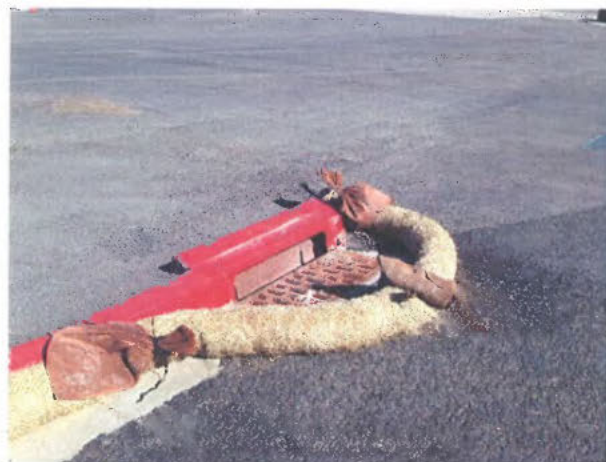
Photo 3

Other catch basins within the corporation yard are also protected with fiber rolls and will be inspected and replaced when warranted.

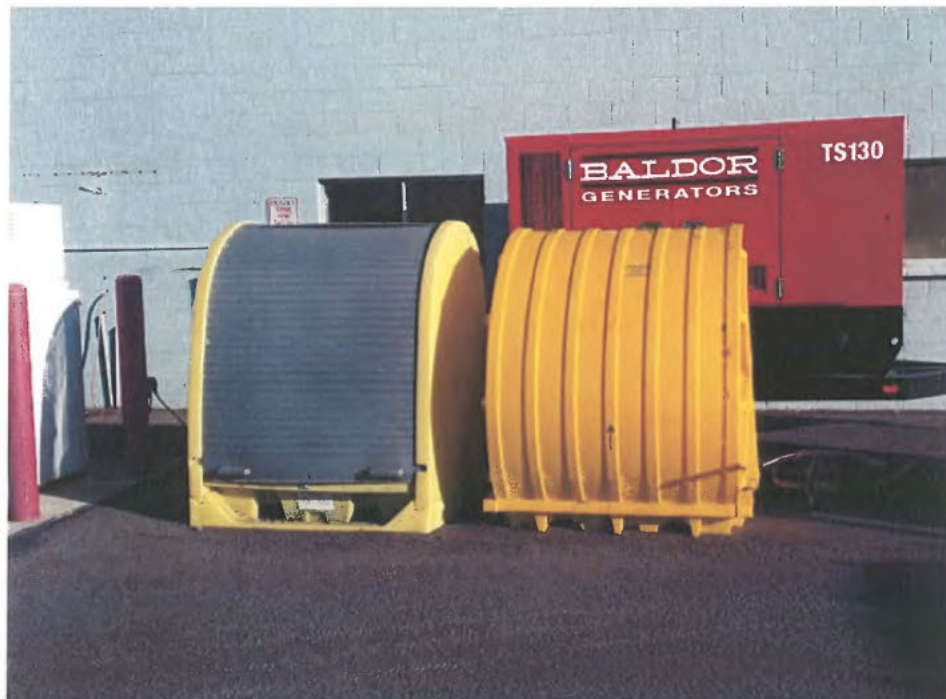
Photo 2: January 13, 2014 (new covered storage)

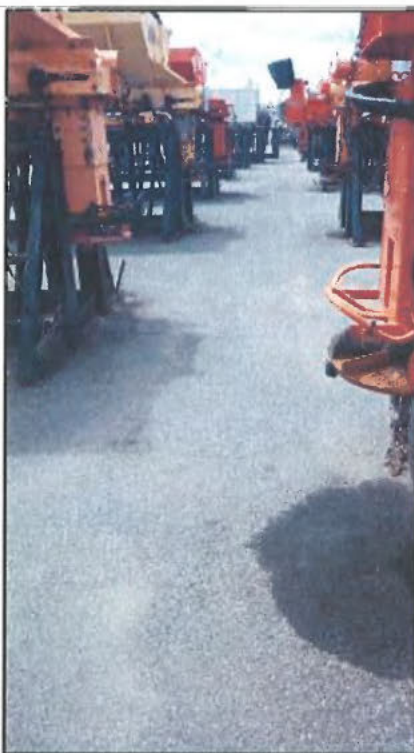
- 2. Waste-oil drums at the Washoe County maintenance yard: at the time of the audit site visit in June 2013, Washoe County Equipment Services were temporarily utilizing uncovered waste-oil storage drums (see Photo 1). The uncovered drums have been removed and additional covered storage has been provided (see photo 2).*

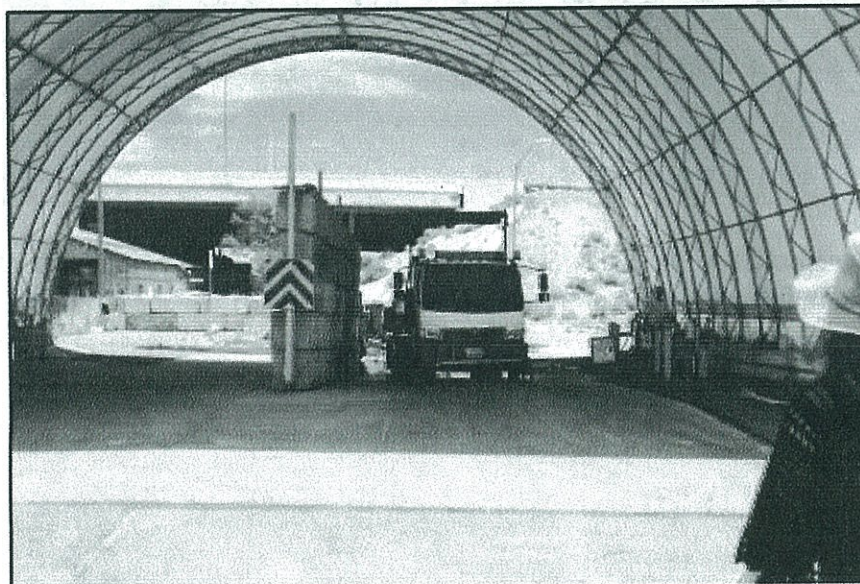
Photo 2 – City of Reno Public Works' wash area for equipment and vehicles. The waste water drains to a sump before treatment in a sand/oil separator and then disposal in the sanitary sewer.

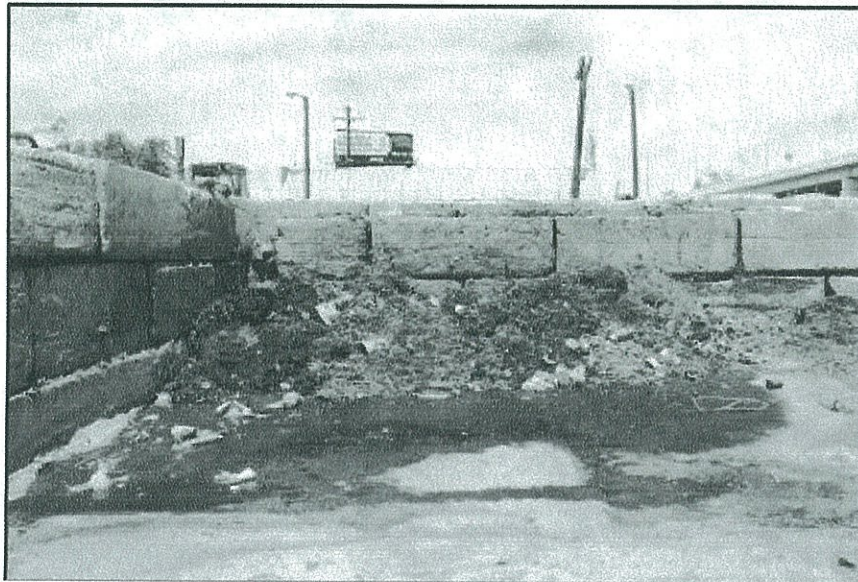
Photo 3 – This is a picture of the sump that accepts waste water from the equipment wash area and the wet street sweeper waste.

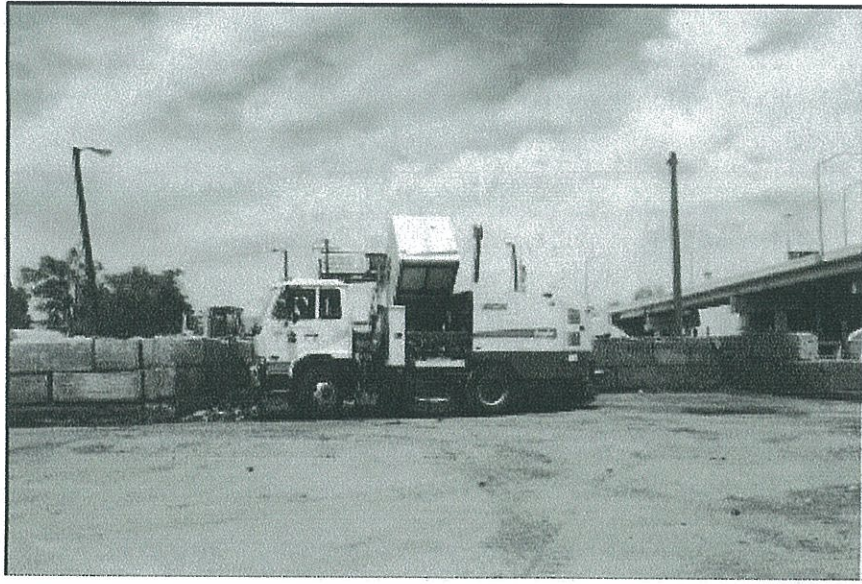
Photo 7 – One of Reno's sweepers emptying its contents into the designated area.

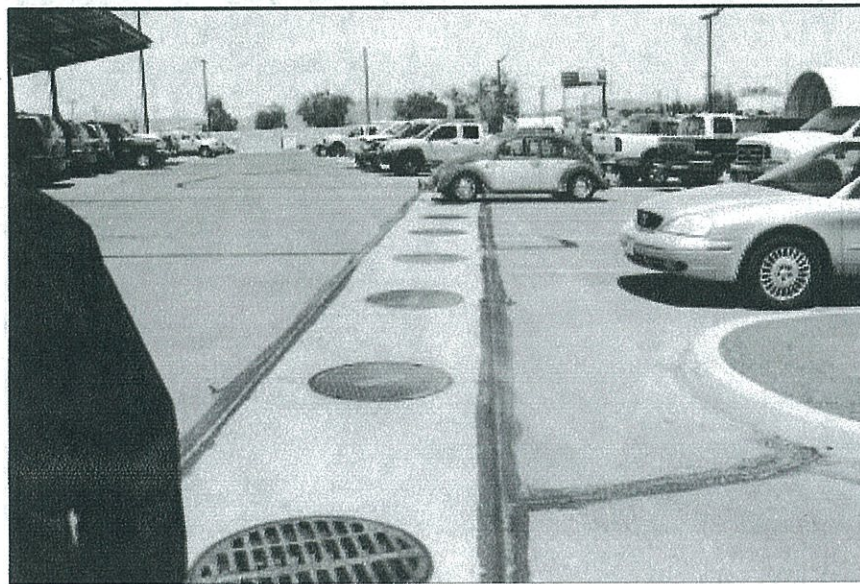
Photo 10 – The oil/water separators that treat any stormwater discharges.

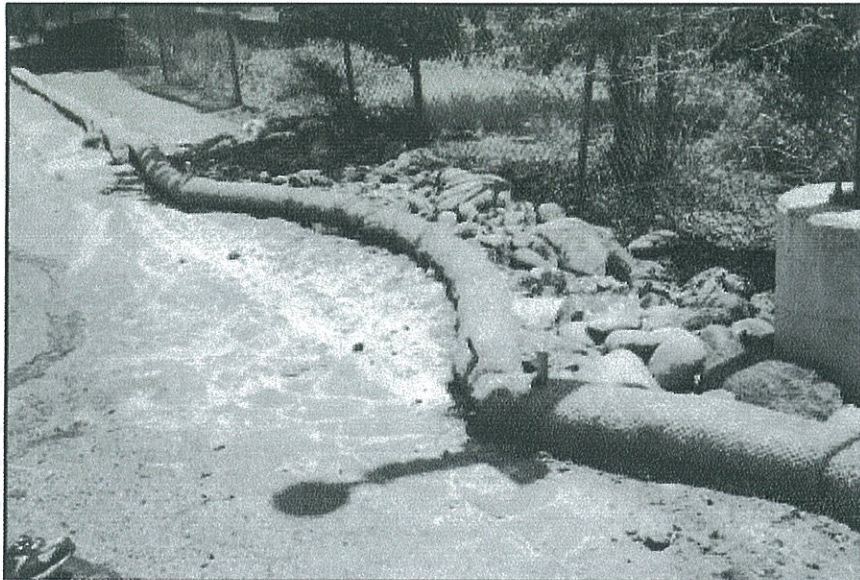
Photo 11 – Photo shows some sediment on the asphalt that could leave the corporation yard unless it is swept up.

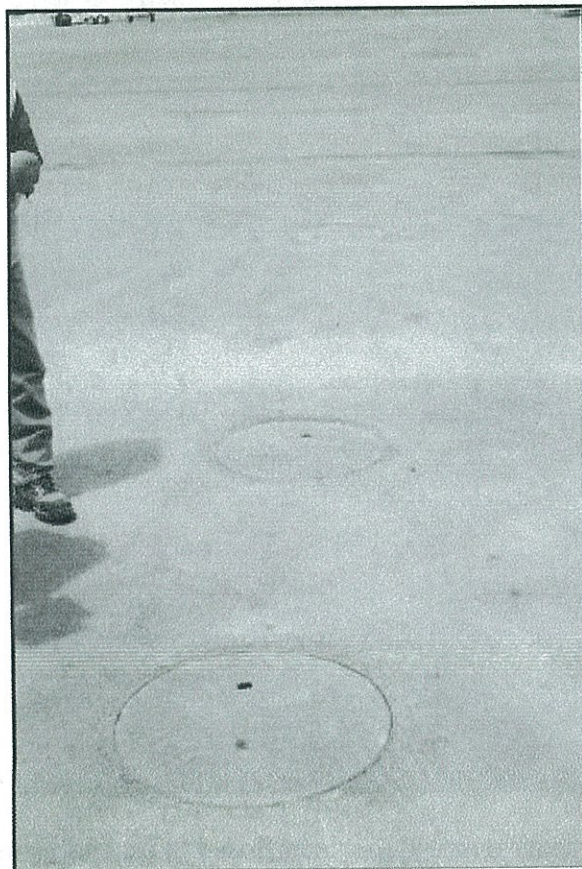
Photo 22 – Washoe County's sand/oil separator at Washoe County's maintenance yard.

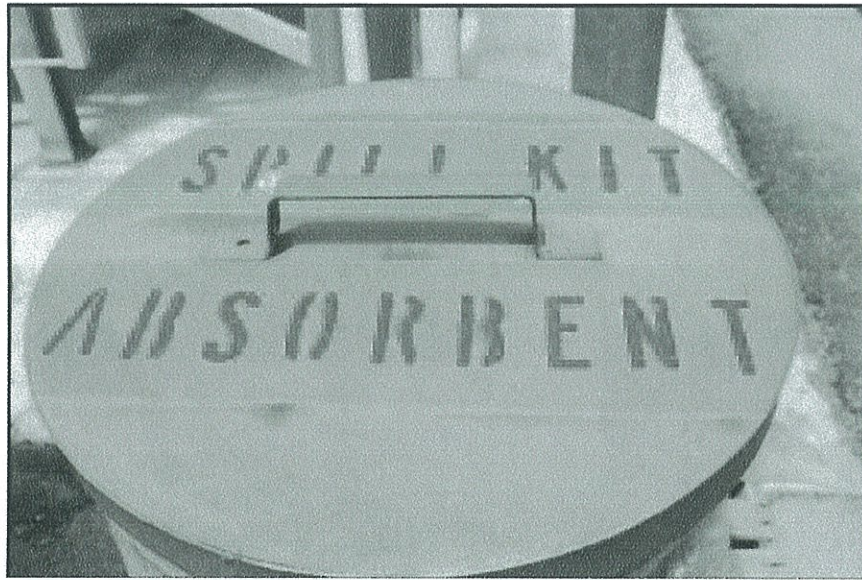
Photo 26 – Absorbent bucket near the used oil storage bin

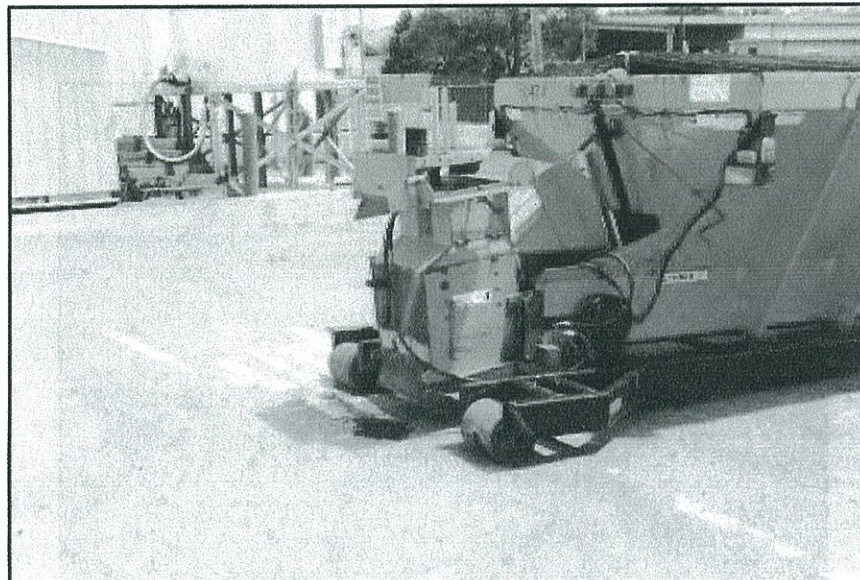
Photo 29 – Racks containing the brine solution containers that can be loaded onto the trucks.

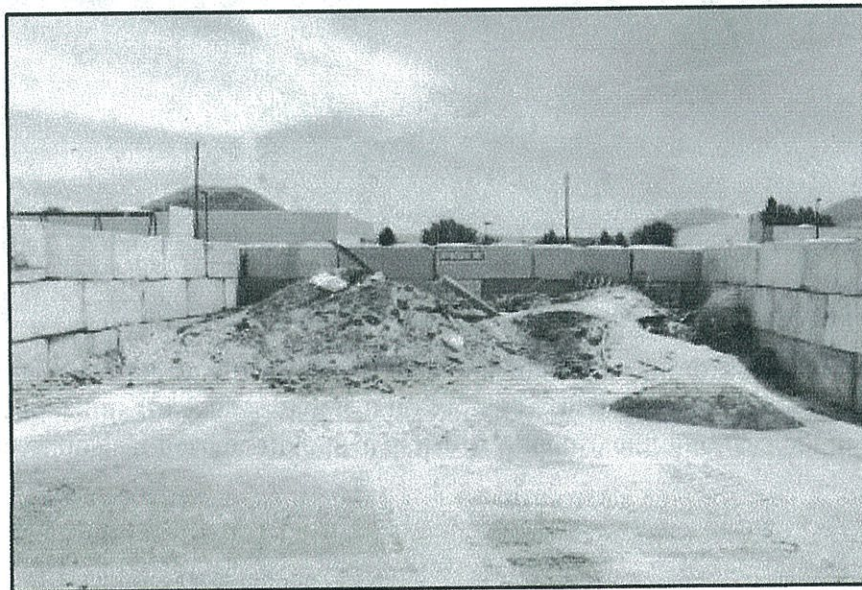
Photo 34 – Dry debris dumped from the sweeper trucks. When the bin becomes full, Washoe County will load the material and dispose of it at the local landfill.

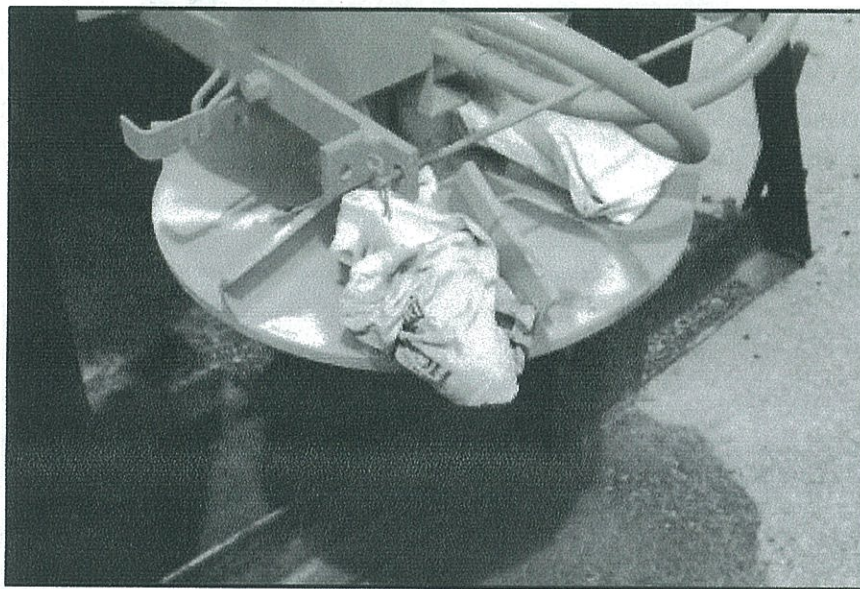
Photo 36 – Hydraulic hoses from the salt/sand spreader that show the driver has attempted to stop any drips by using rags to soak up the oil. This is a good first step to reduce oil spills, but there is evidence that oil has spilled in the past onto the asphalt. A drip pan should be used instead to catch any drips.

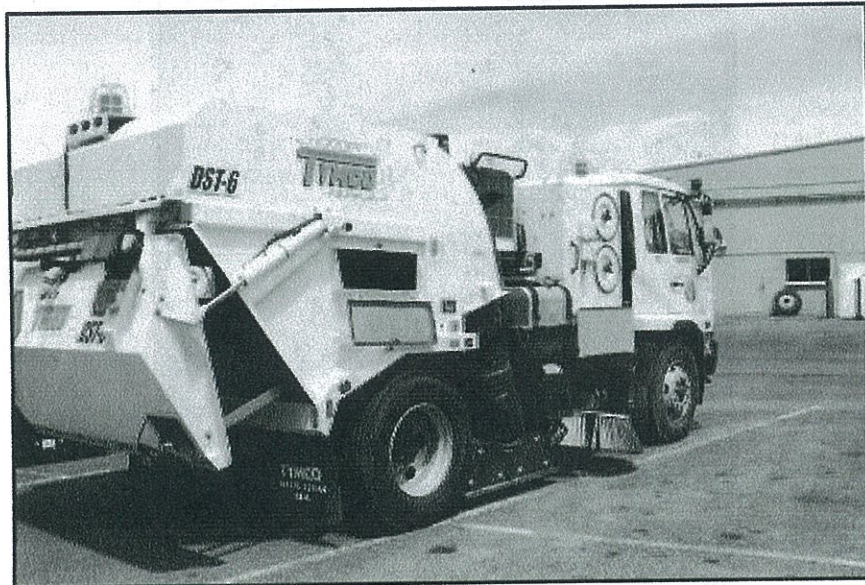
Photo 37 – One of Washoe County’s street sweepers. This sweeper is equipped with a HEPA filter to sweep up extremely fine particles.

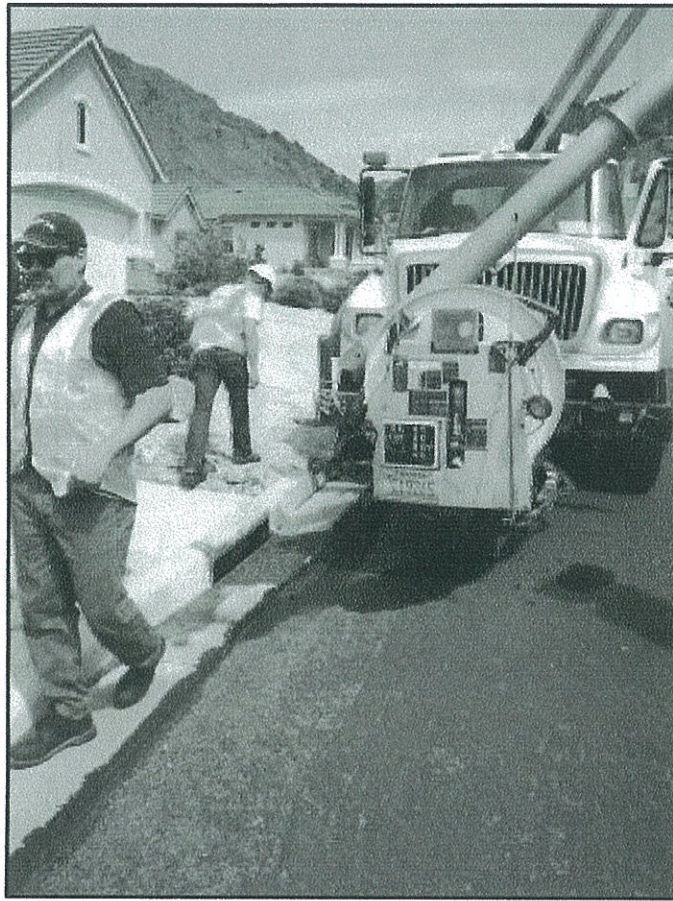
Photo 41 – Storm drain inlet cleaning being performed by Washoe County maintenance crews.

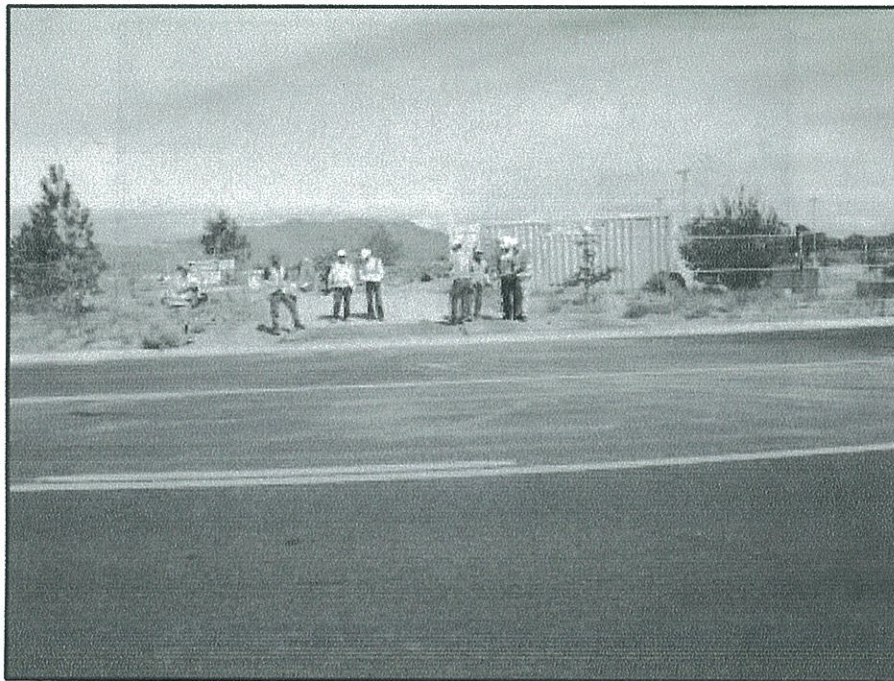
Photo 46 – View looking east at the rumble strip at the exit of the Washoe County water park construction site. This was the only BMP listed on the one-page SWPPP map.

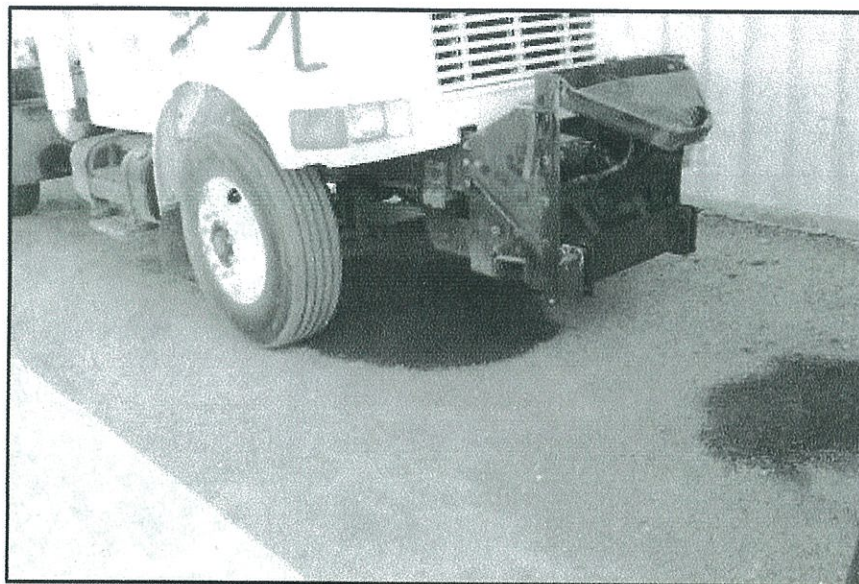
Photo 53 – Oil spills beneath one of the maintenance trucks. Drips pans should be placed beneath leaks or dripping hydraulic hoses.

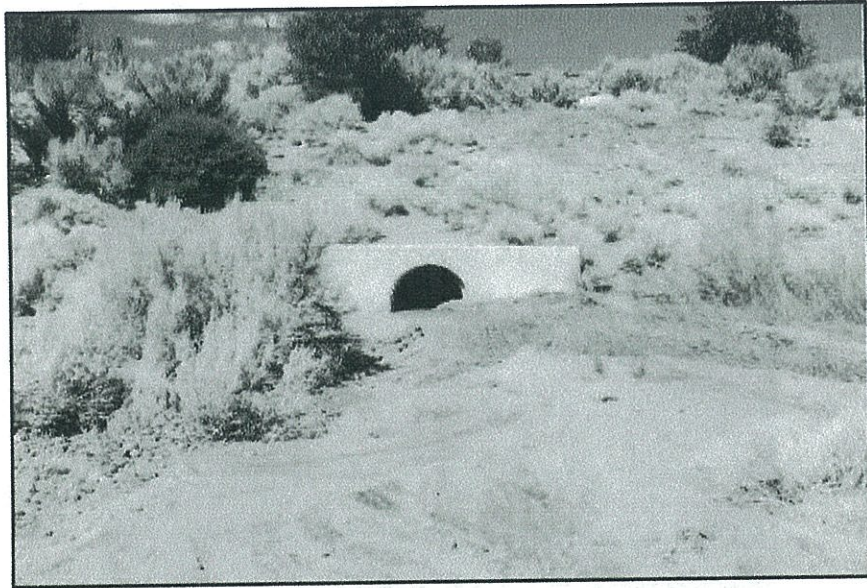
Photo 55 – View looking west of drainage culvert underlying Las Posada Street within the Kiley Ranch North Development. This drains the detention basin called “Desert Vista Pond 1,” which primarily receives drainage from natural landscape up-canyon of the development. Sparks’ employees mentioned this also received a lot of flow in the storm on June 10. They said the City of Sparks’ maintenance crew would need to clean this out, including the culvert.

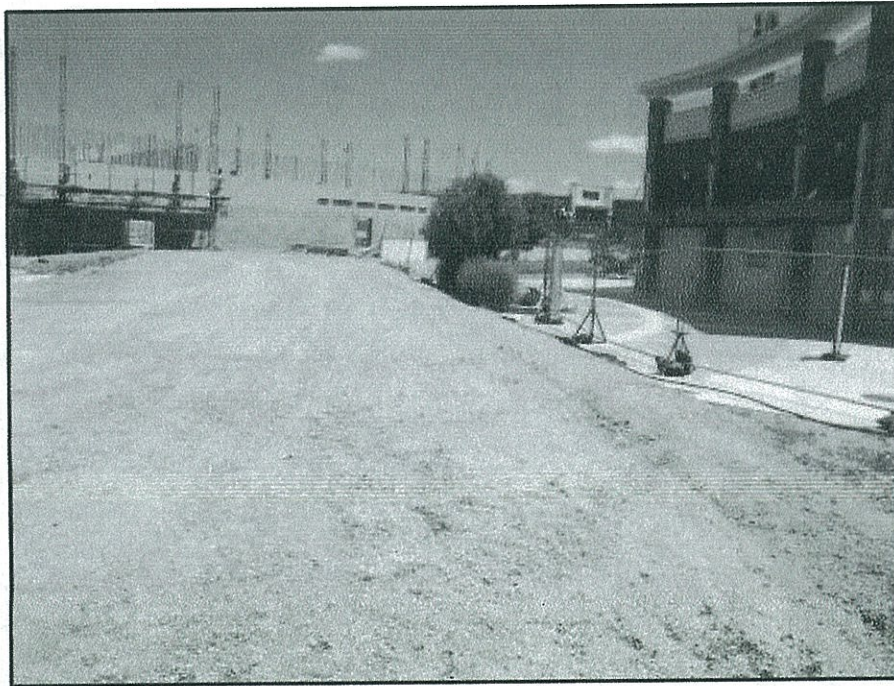
Photo 60 – Along the south perimeter of the IMAX construction site. Immediately to the right in the photo is the Legends Shopping area. Note there are no perimeter controls along this portion of the site to prevent stormwater discharges from leaving the site.

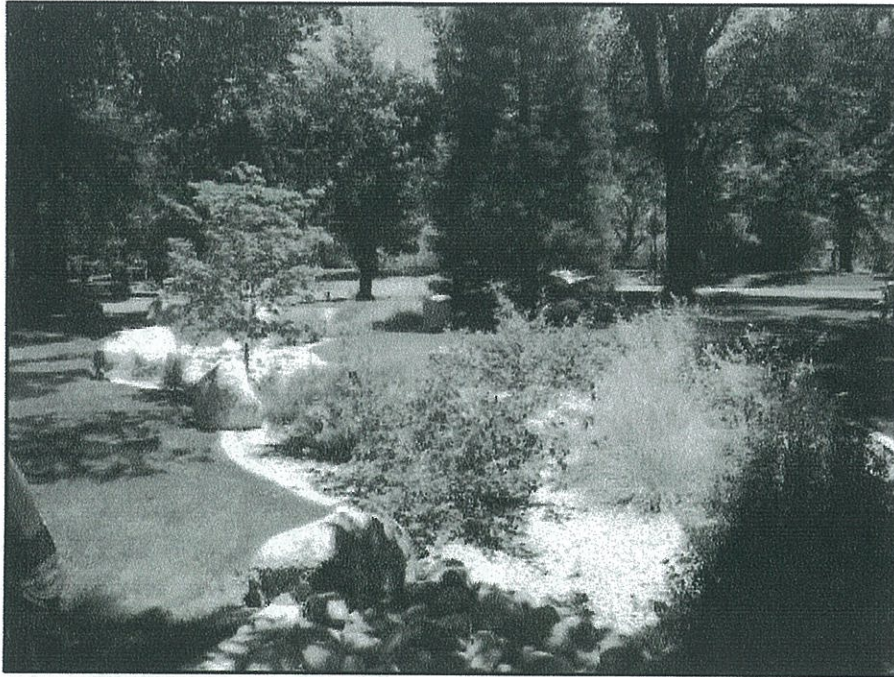
Photo 61 – City of Reno, McKinley Arts and Cultural Center. This is a Low-Impact Development project completed by the City of Reno in 2010. It incorporates rain gardens, low water plants, and pervious pavement, among other things to increase water infiltration on-site and reduce pollution discharges during storm events from leaving the site. The Truckee River is close to this site and signs are posted there and at the McKinley Center to help educate people about LID and water pollution.

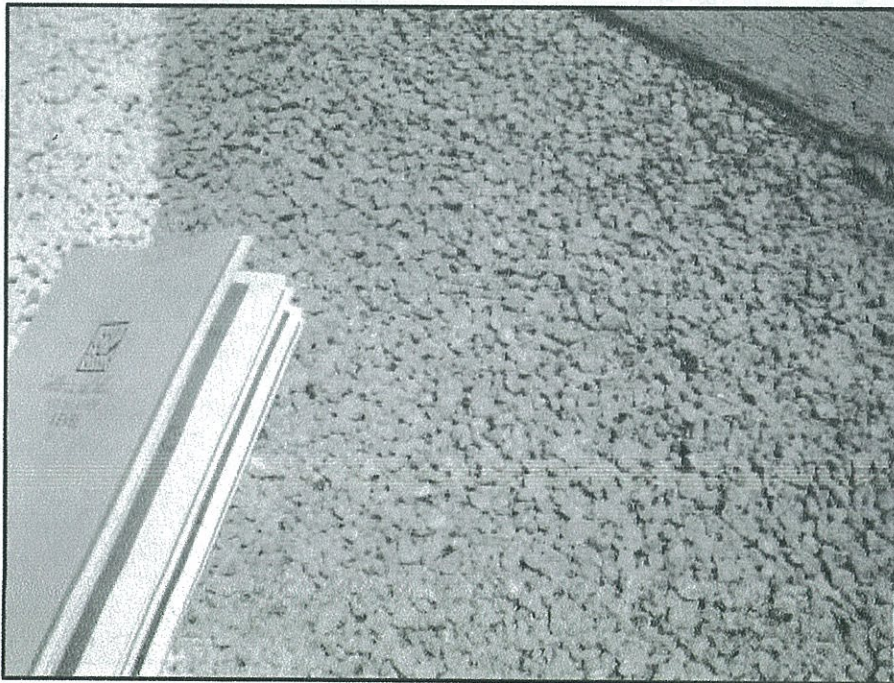
Photo 62 – Close-up of the impervious pavement at the McKinley Arts Center.

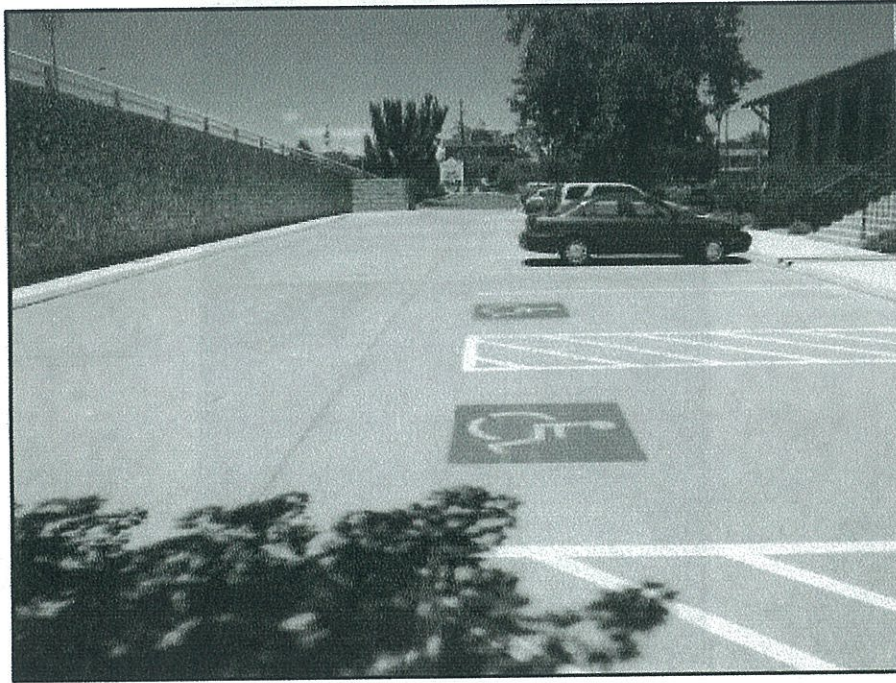
Photo 63 – Parking lot at McKinley Arts Center, City of Reno. The parking lot is paved with pervious pavement.

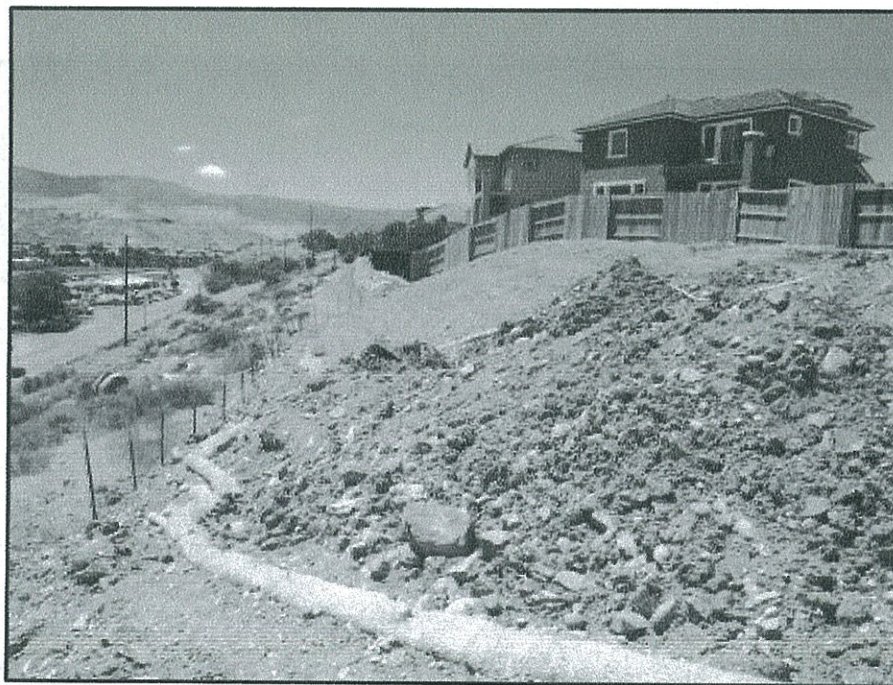
Photo 66 – Looking west along the south-facing slope of the Bella Rio construction project. Recent utility work involved some soil disturbance which prompted the contractor to install a straw waddle. Unclear why this was installed but no BMPs were installed elsewhere along the slope.

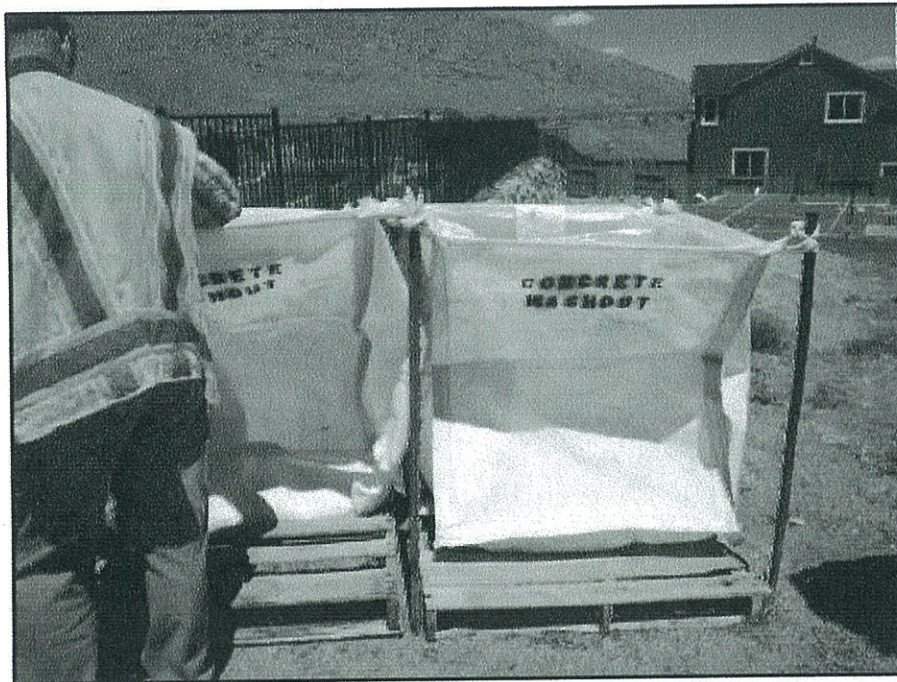
Photo 67 – Concrete washout bags at the Bella Rio construction site.

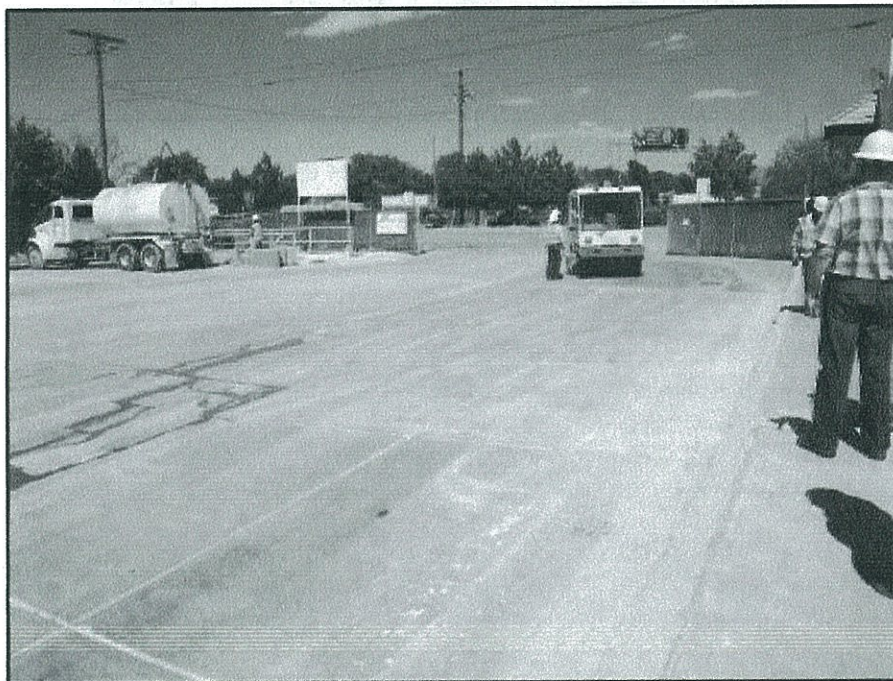
Photo 72 – View looking northeast at the front gate from immediately inside the Cemex, Reno Facility. Note the non-stormwater flow to the left and company-owned sweeper in the center of the photo. According to the area manager, the onsite water flows to the basin immediately to the left inside the front gate. The sweeper was operating continuously during our site visit in the area just inside the gate and along Galletti Way, the public street just outside the gate. Despite the cleaning operations, there was evidence of track-out from this site.

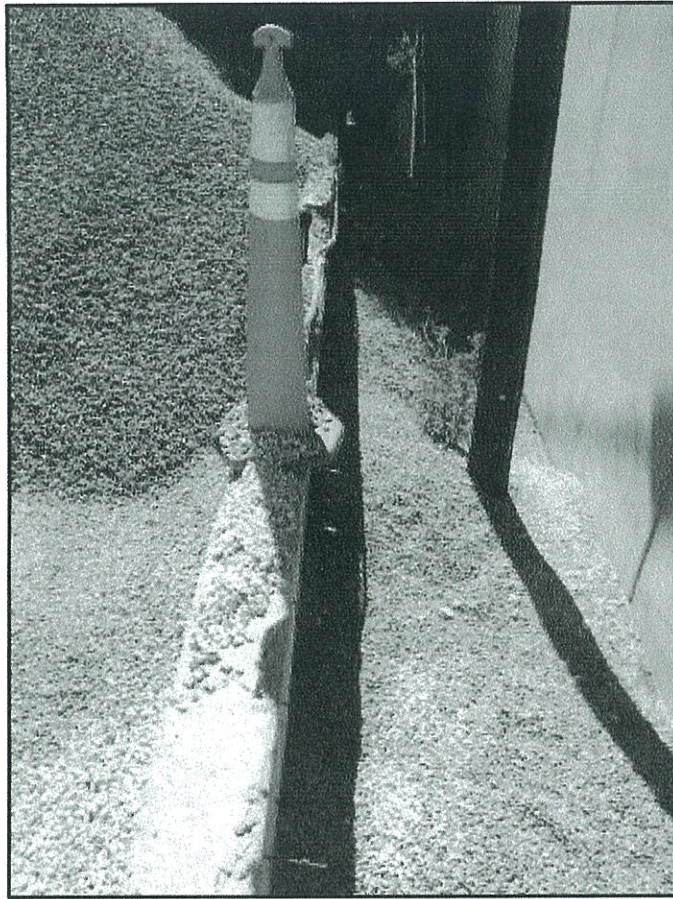
Photo 74 - View looking west along the northern perimeter of the Cemex Ready-mix plant. Note, again, the lack of a proper perimeter structure to prevent material from leaving the site.

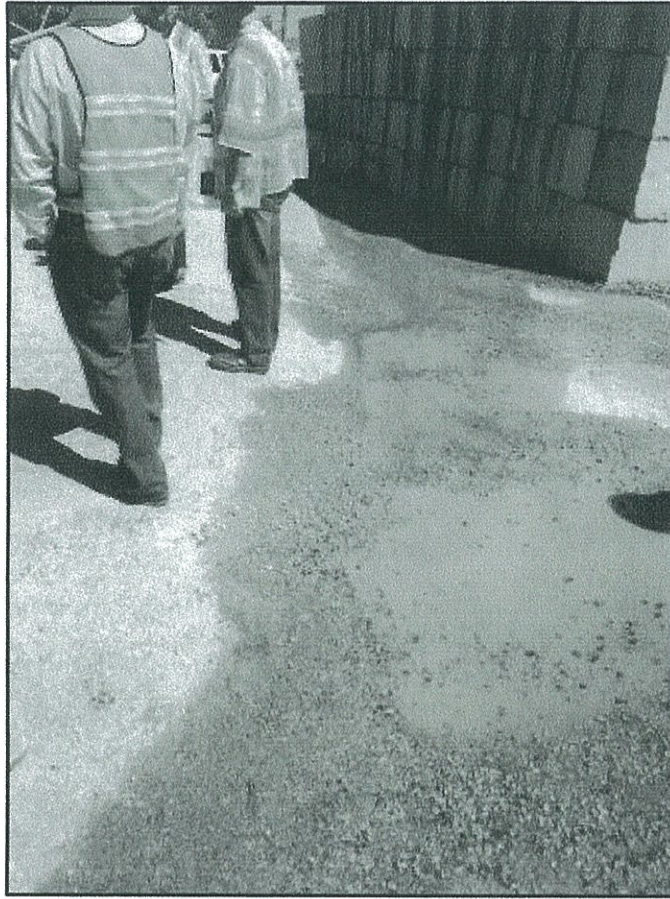
Photo 77 – View of aggregate wash water flowing on ground at the Cemex Ready-mix plant. This was is collected in the basin immediately inside the front gate.

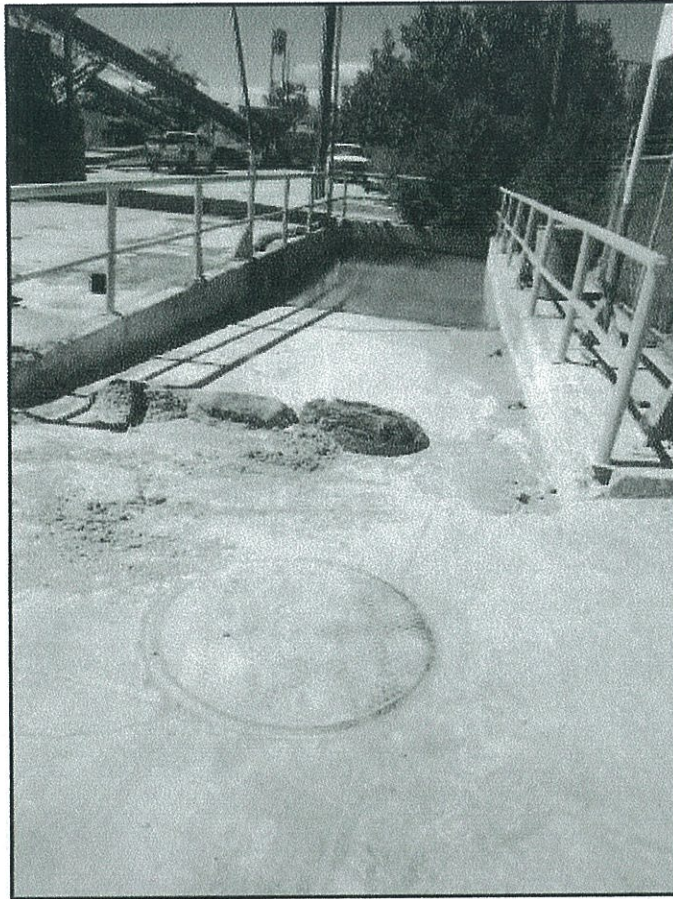
Photo 78 – View looking north of one of two water collection basins at the Cemex Ready mix plant in Reno. Water is collected and used as dust suppressant in the wash yard to the east across Galletti Way.

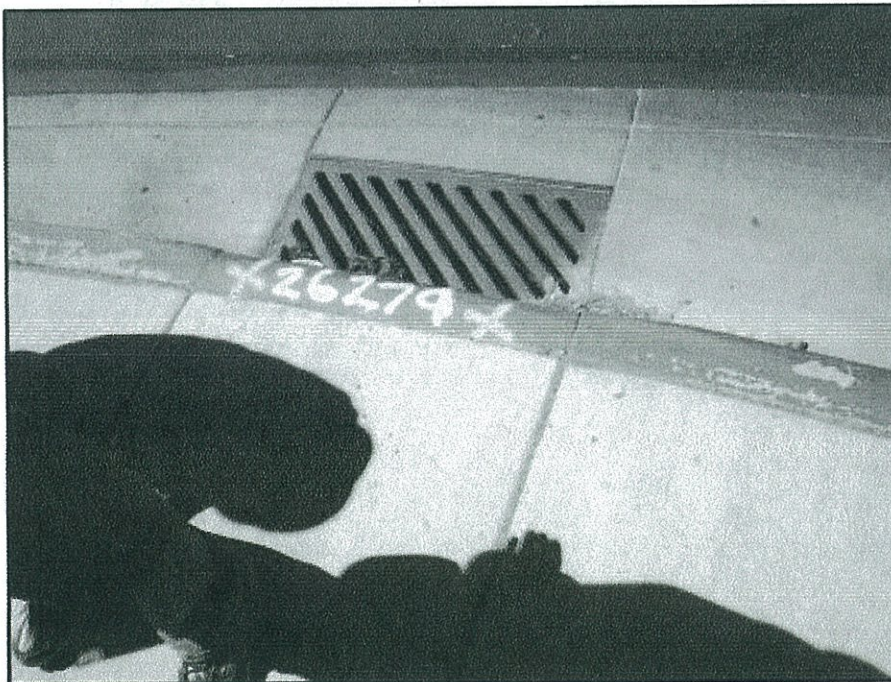
Photo 79 – Storm drain at the corner of E. Galletti Way and 4th Street in Reno. Immediately adjacent to this drain is the Cemex Ready-Mix plant where raw materials stored at the plant are overflowing certain structures. The poor on-site storage practices (including track-out) at this facility may lead to material entering this and other stormdrains in the area.

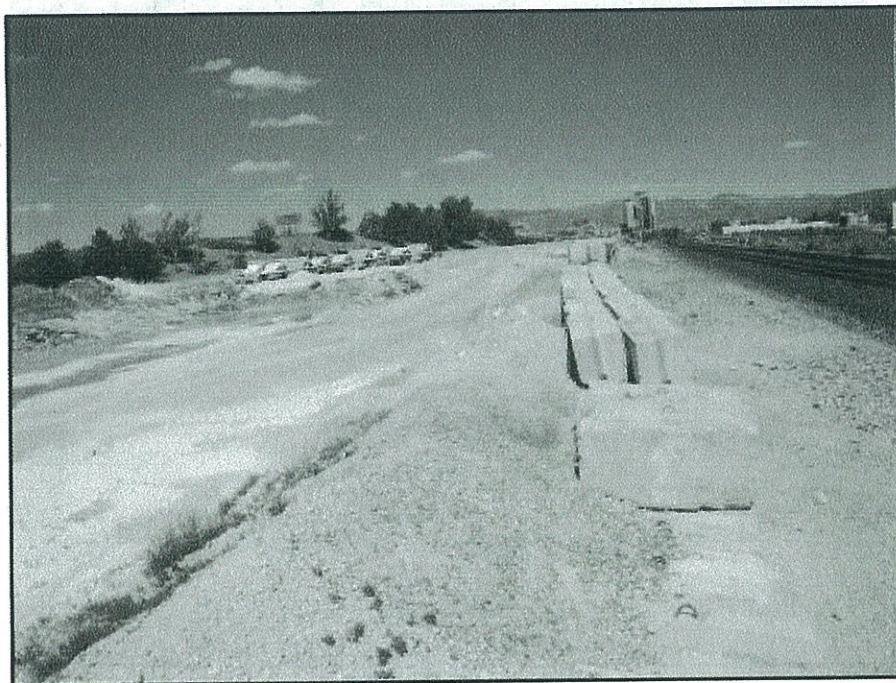
Photo 81 – View looking east of the Wash-Out Yard, across the street on Galletti Way from the Cemex Ready-mix plant. According to the Area Manager at Cemex, this sprawling open area is located in the City of Sparks (not Reno) and used by Cemex employees to wash Cemex trucks. There appeared to be material from this facility that also was spilling over or through some of the perimeter structures.

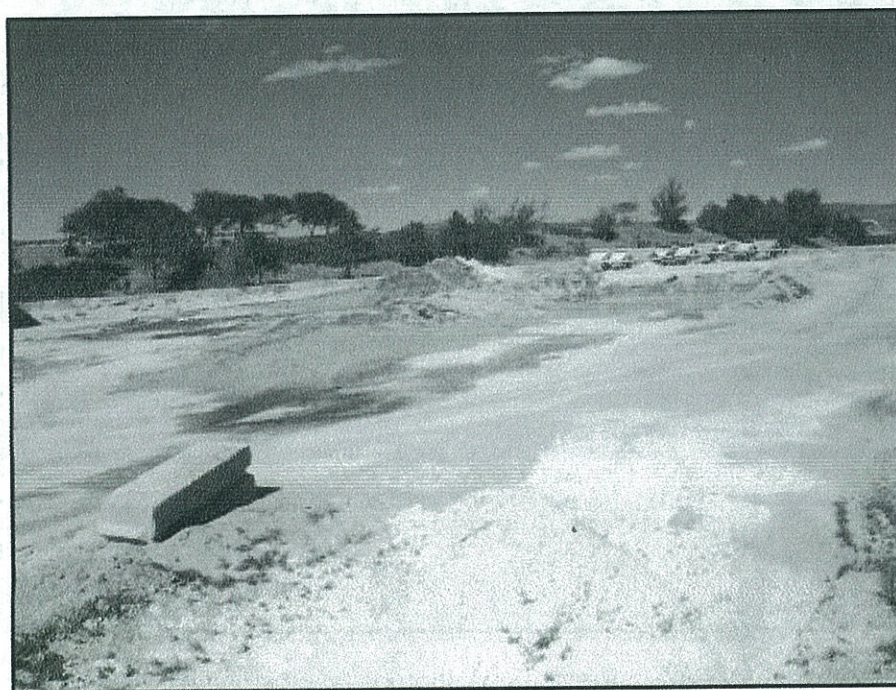
Photo 82 – View looking northeast of the truck wash out area. Note the standing water in the low-lying areas to the east from where the photo was taken.

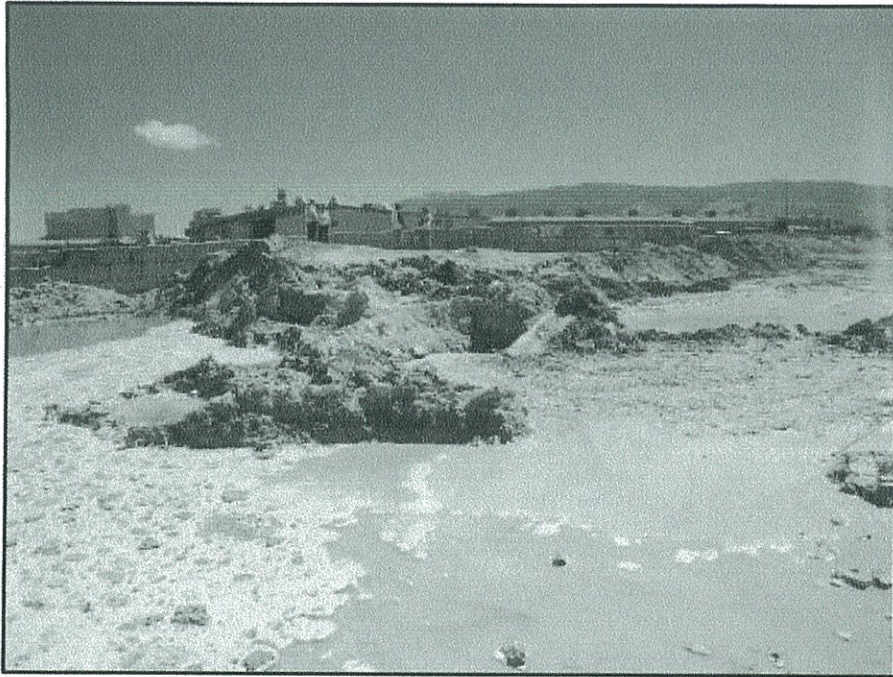
Photo 83 –View looking south west at the washout area of the Cemex facility in Reno. Note the standing water in the foreground and the mound of material stockpiled in the area. The Area Manager indicated that 30-45 trucks use this facility each day to dump excess concrete (if any) and wash out their trucks.
